UNITED STATES ENVIRONMENTAL PROTECTION AGENCY

Re: Notice of Violation
Heritage Environmental Services
EPA I.D.: IND 093 219 012

INTRODUCTION	3
FACILITY BACKGROUND	3
INVESTIGATION METHODS	4
ON-SITE INSPECTION SUMMARY	6
PROCESS OVERVIEW	6
Waste Approvals	7
Waste Acceptance, Receiving, and Tracking	8
Stabilization of Hazardous Waste	10
Dose Response Testing and Post-treatment Verification Sampling and Analysis	11
Wastewater Treatment Plant	12
Additional Treatment Processes	12
Heritage Roachdale Landfill	13
LABORATORY ACTIVITIES SUMMARY	15
SAMPLE RECEIPT AND ANALYSIS	15
ANALYTICAL PROCEDURES AND ANALYSTS	15
ANALYTICAL RESULTS	16
DATA QUALITY SUMMARY	18
SUMMARY OF OBSERVATIONS	20
KEY OBSERVATIONS	20
AREAS OF CONCERN	20
TABLES	
1 Laboratory Sample Delivery, Receipt, and Transfer	15
2 Analytical Procedures and Analysts	15
3 Laboratory Analytical Results Results for 14 Metal Constituents Covered by Universal Treatment Standards	17
4 Laboratory Analytical Results for Six Analytes Not Covered by Universal Treatment Standards	18
FIGURE	
1 Dose Response Testing Flow Diagram	9

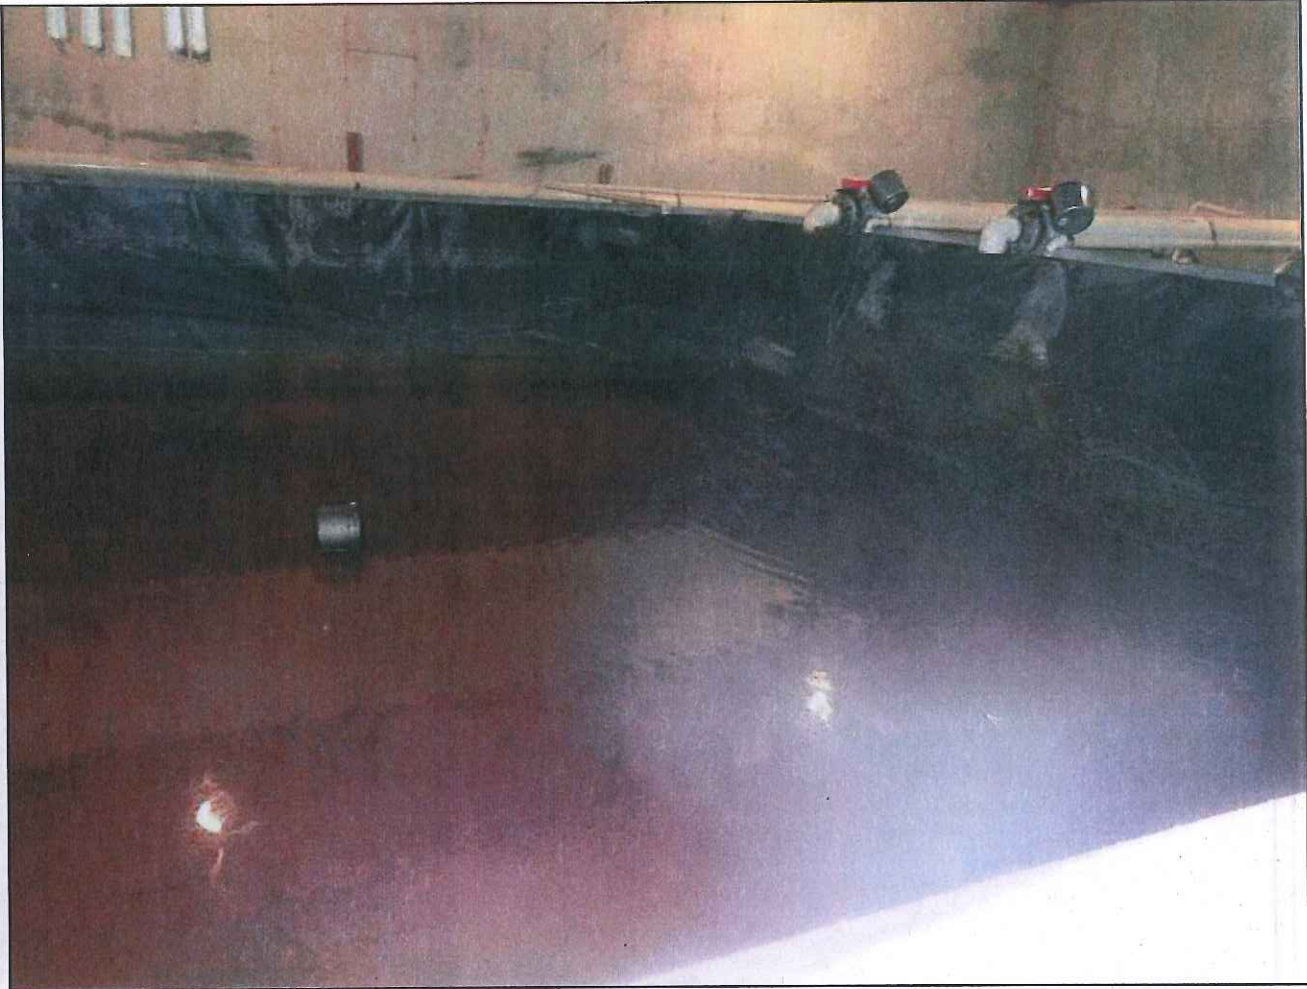
Attributes	
File Name	RIMG0038.JPG
Date Time Stamp	7/19/2012 3:58:03 PM
Photographer:	A. Ruhs
Latitude	
Longitude	
Photo Direction	
Description:	Inside of leachate collection tank for landfill unit 1, phase 1.

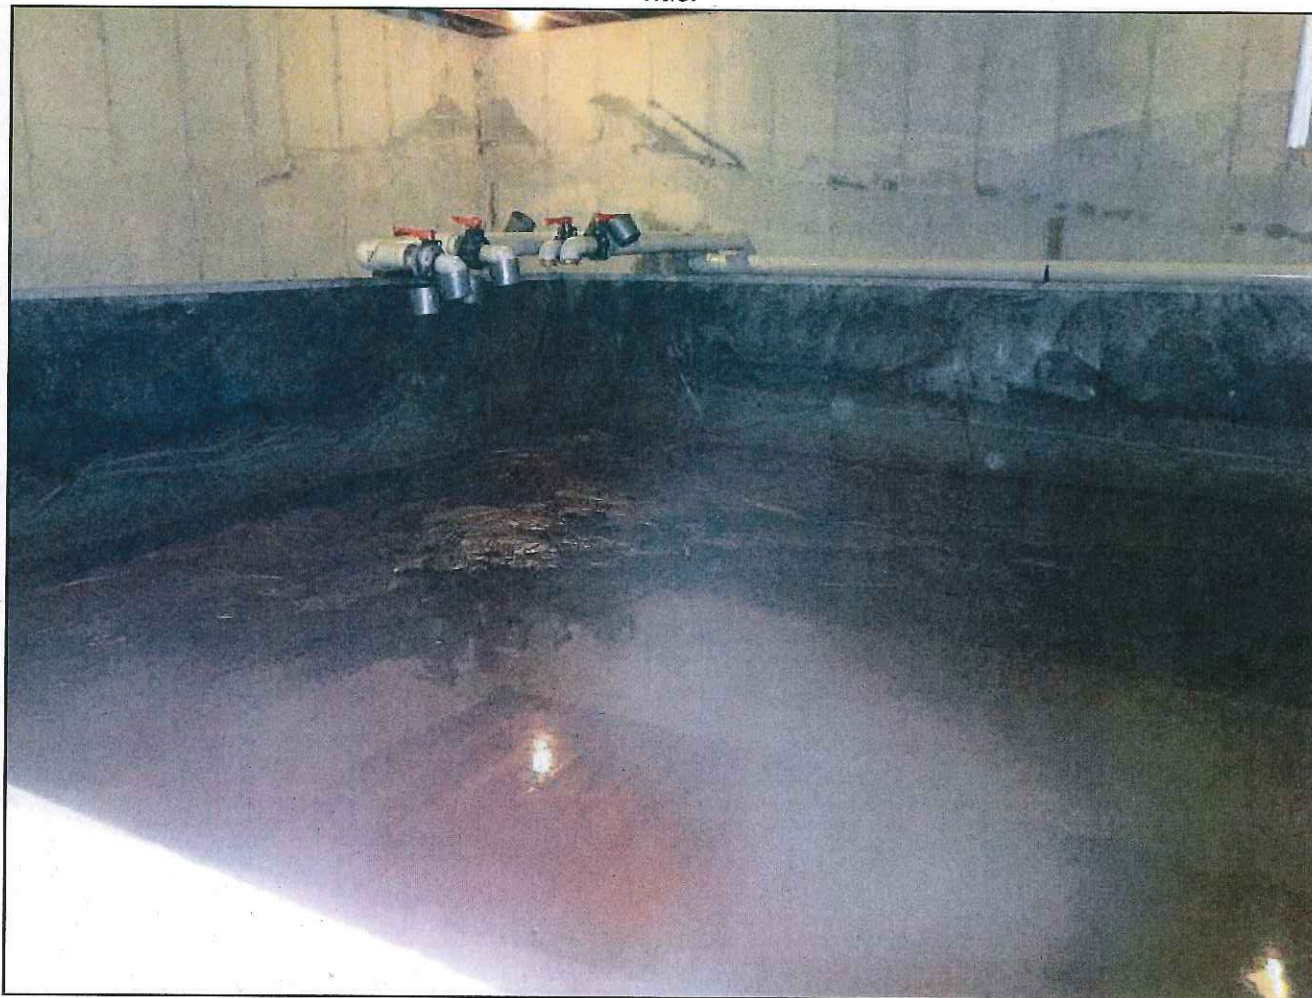
Attributes	
File Name	RIMG0039.JPG
Date Time Stamp	7/19/2012 3:58:10 PM
Photographer:	A. Ruhs
Latitude	
Longitude	
Photo Direction	
Description:	Inside of leachate collection tank for landfill unit 1, phase 1. Inlet pipes from primary leachate from cells 3-6.

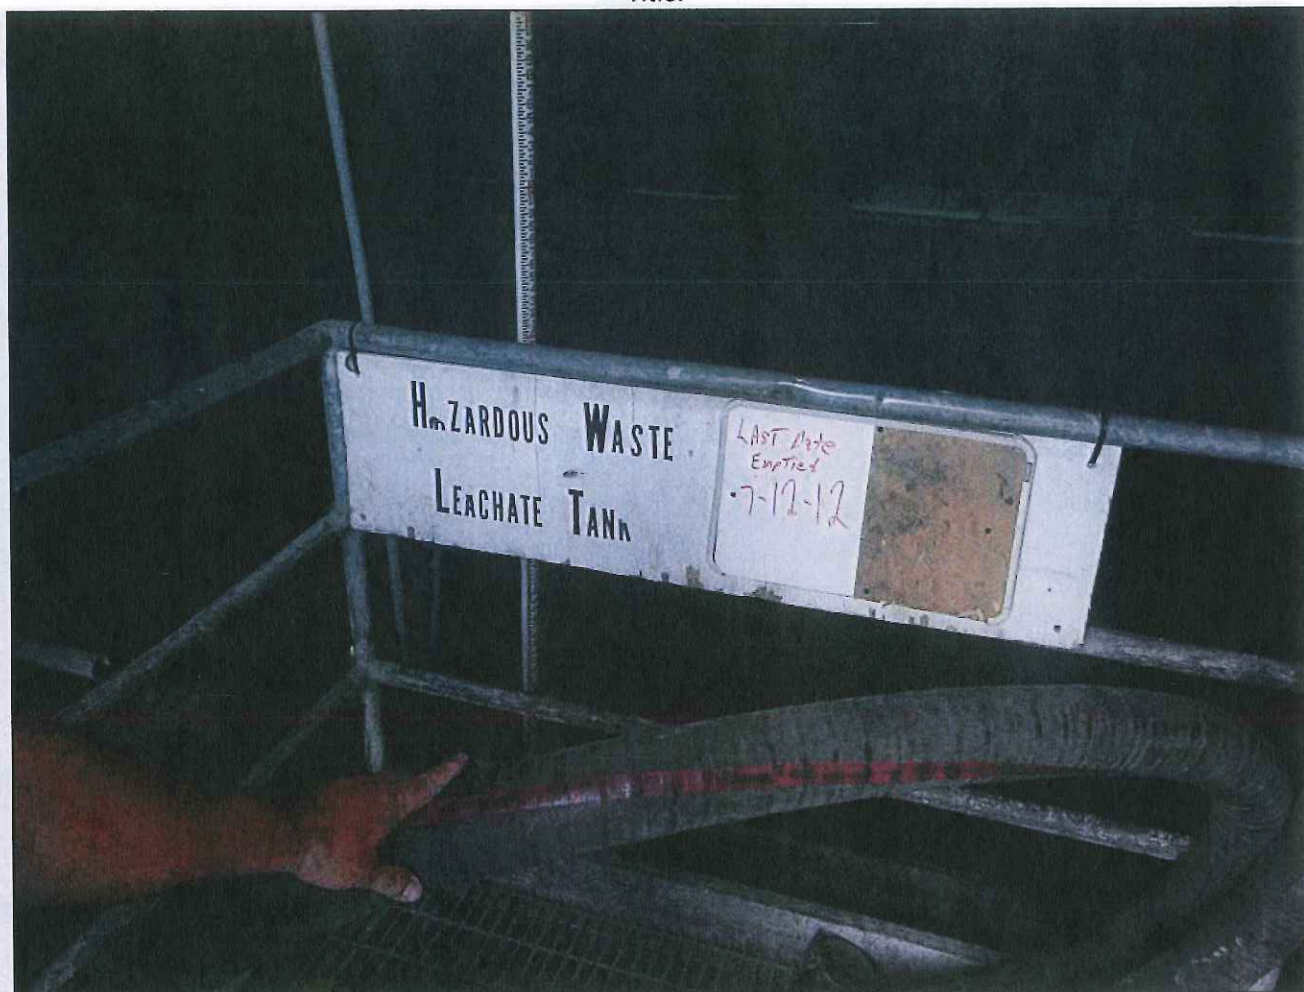
Attributes	
File Name	RIMG0040.JPG
Date Time Stamp	7/19/2012 4:06:54 PM
Photographer:	A. Ruhs
Latitude	N 39° 50' 33"
Longitude	W 86° 55' 21"
Photo Direction	212° SSW
Description:	Sign at less-than-90-day leachate collection tank for landfill unit 1, phase 2 (cells 11-13).

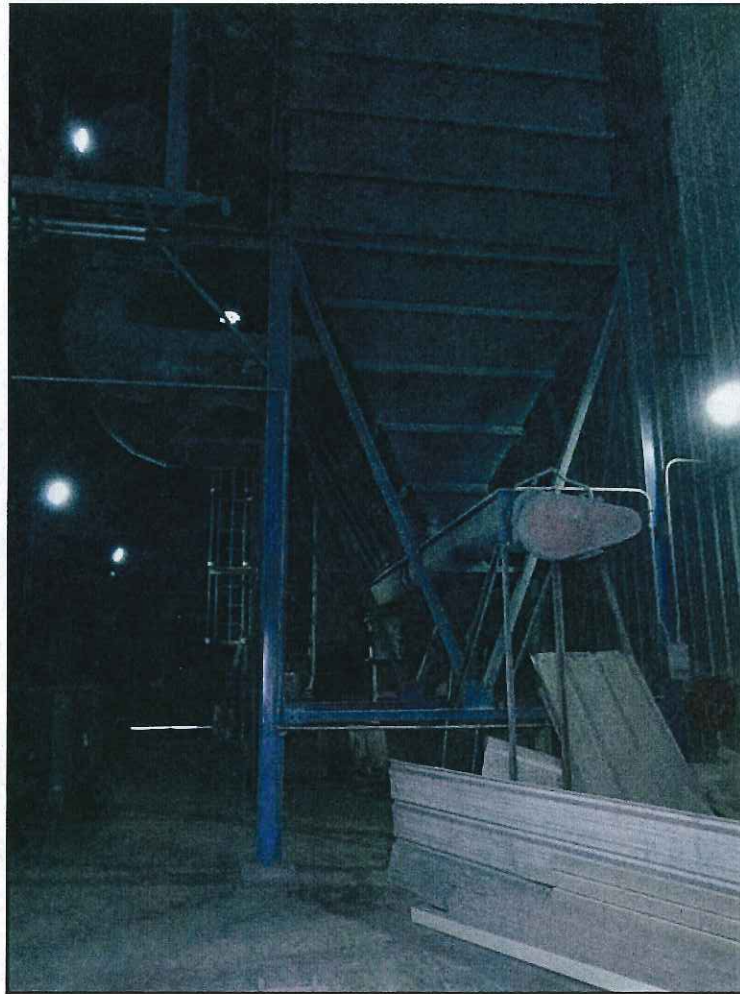
Attributes	
File Name	RIMG0047.JPG
Date Time Stamp	7/20/2012 10:38:48 AM
Photographer:	A. Ruhs
Latitude	N 39° 44' 53"
Longitude	W 86° 18' 02"
Photo Direction	244° WSW
Description:	Baghouse area for the CB-W fixation building.

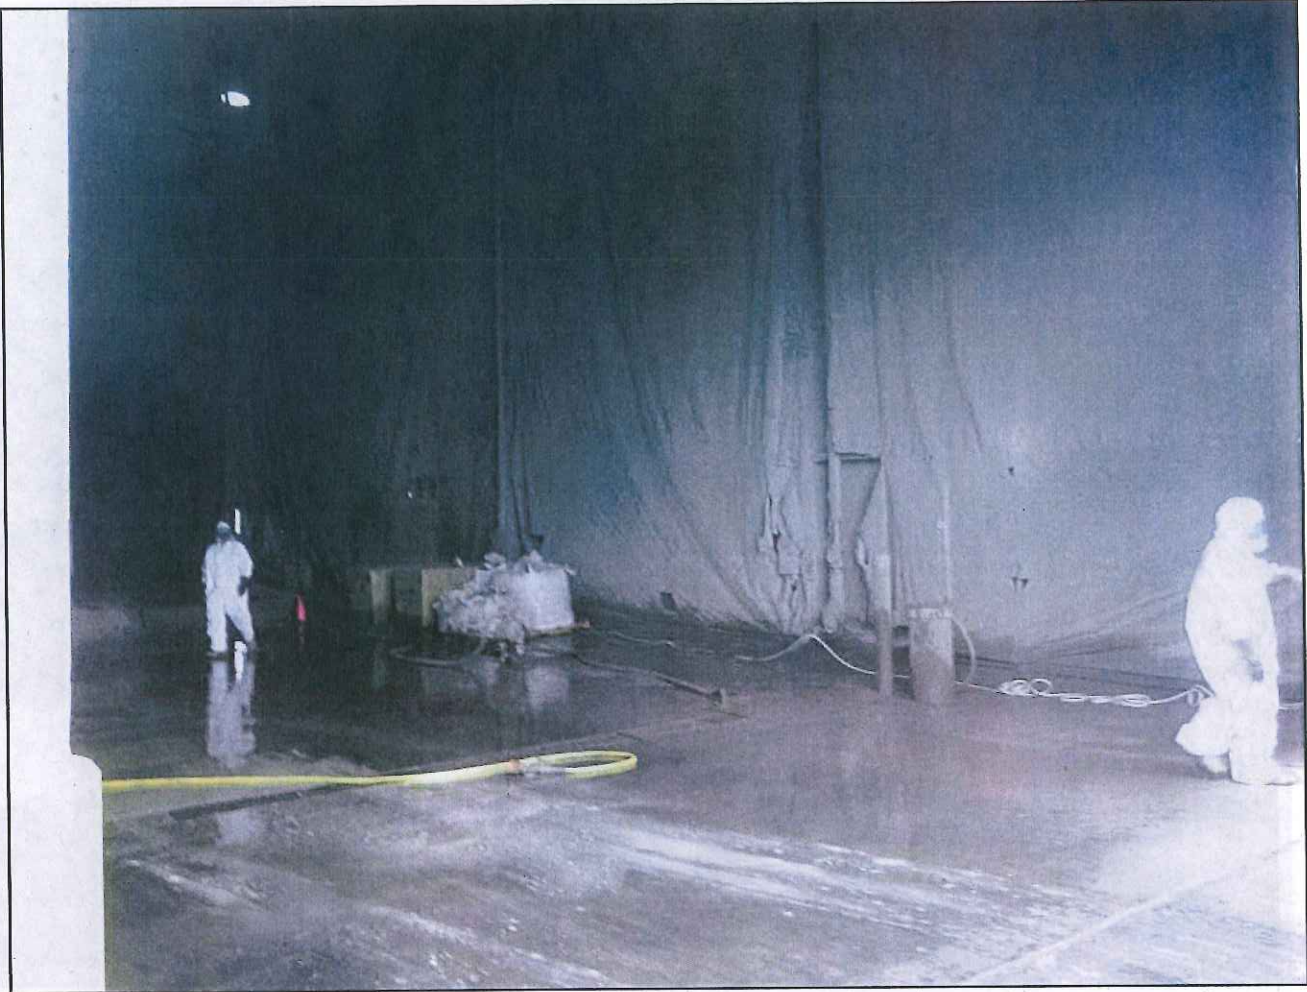
Attributes	
File Name	RIMG0050.JPG
Date Time Stamp	7/20/2012 10:51:20 AM
Photographer:	A. Ruhs
Latitude	
Longitude	
Photo Direction	
Description:	Inside of CB-W fixation building. Dump floor -1 (DF-1) treatment tank to the right, and DF-2 to the left.

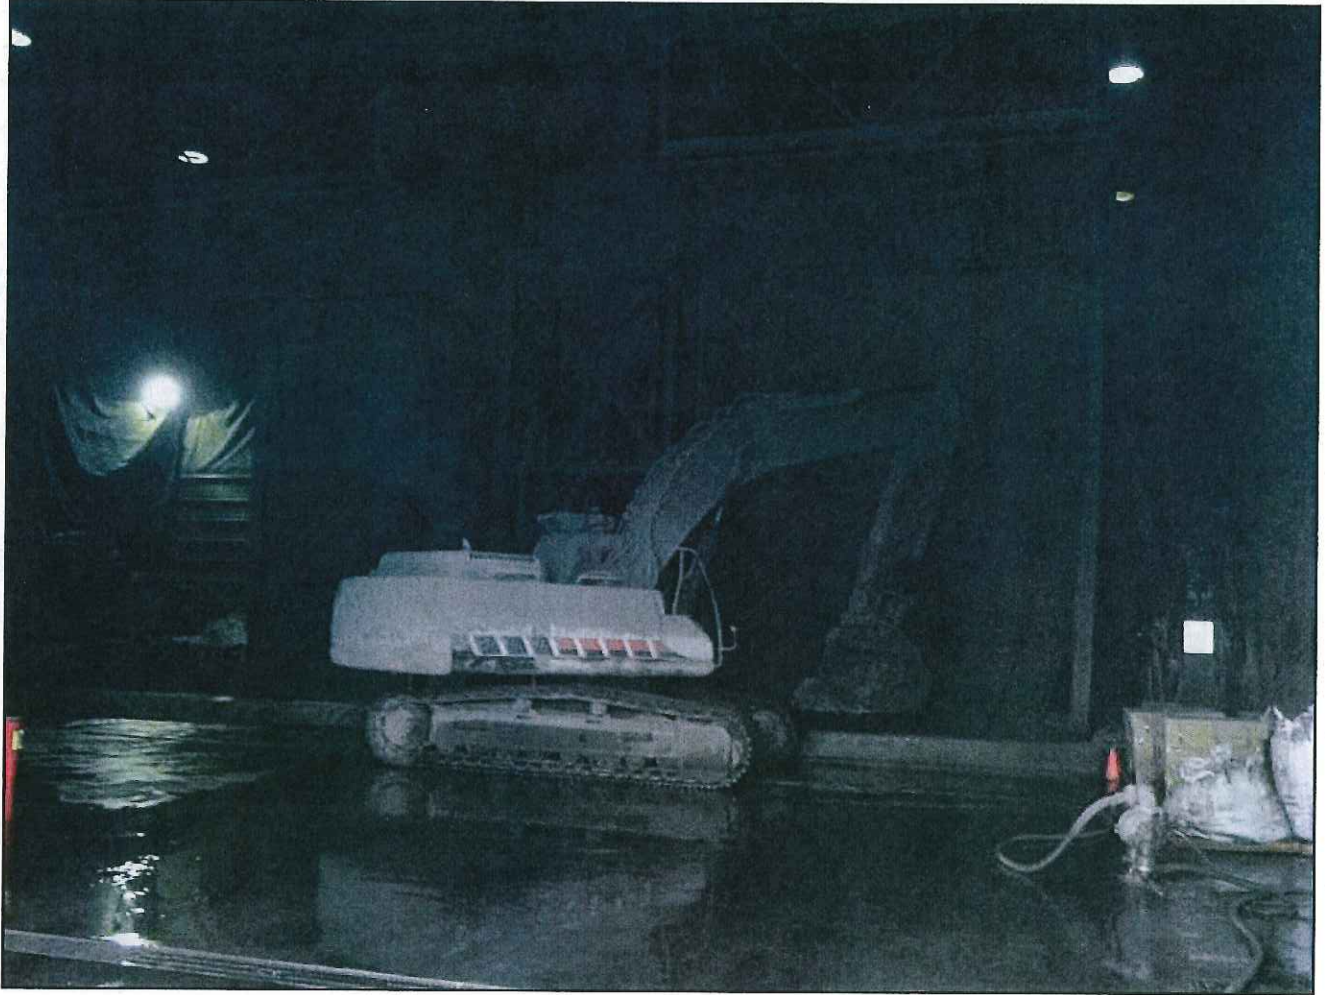
Attributes	
File Name	RIMG0057.JPG
Date Time Stamp	7/20/2012 10:54:56 AM
Photographer:	A. Ruhs
Latitude	
Longitude	
Photo Direction	
Description:	Close-up on DF-1.
